KOOTENTAI DEVELOPMENT IMPOUNDMENT DAM TOE DRAIN INSPECTION REPORT

APRIL 1, 2010

BHI File No.: R.56.1

Kurt Hafferman, P.E.
April 1, 2010

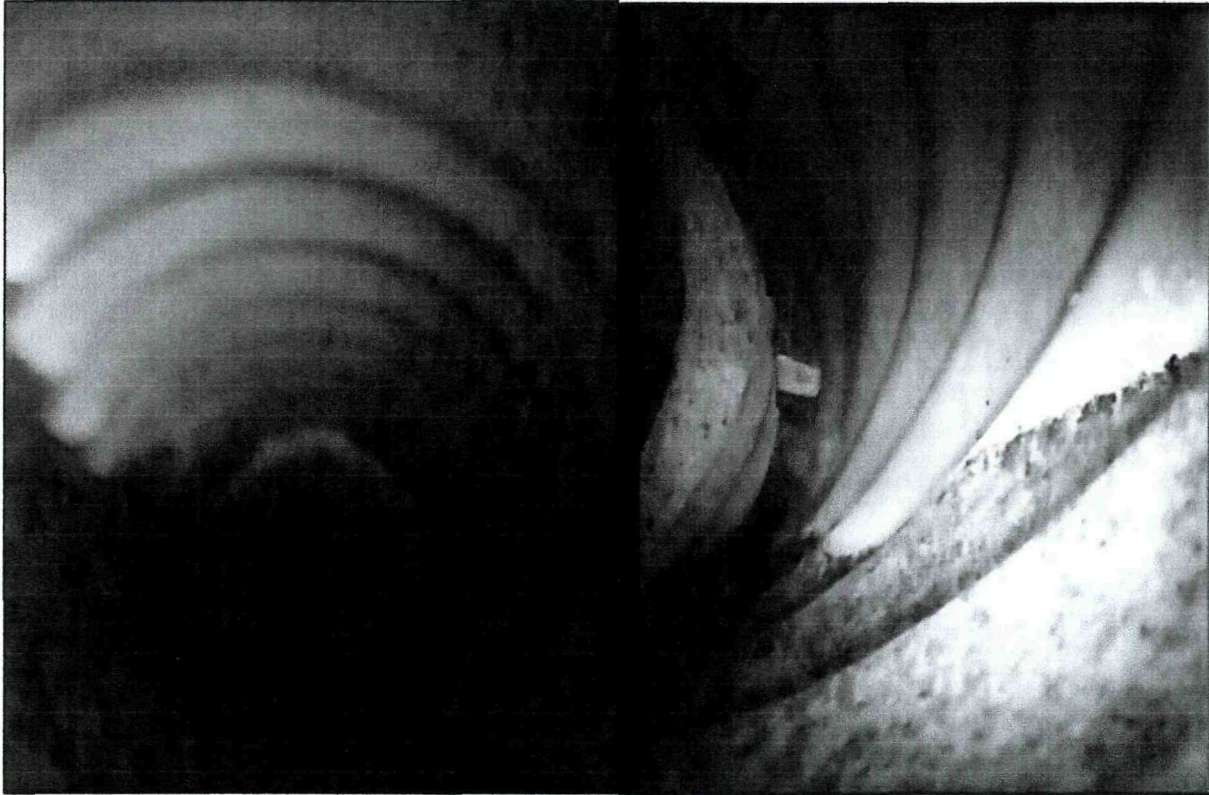
Figure 1: Drain 1 Transition

Drain 1: Drain 1 is located in the far right abutment and starts with a 12-inch corrugated metal pipe (CMP) then transitions into a 10-inch reinforced concrete pipe (RCP) approximately 10 ft. from the outlet. The transition is shown in Figure 1 below:

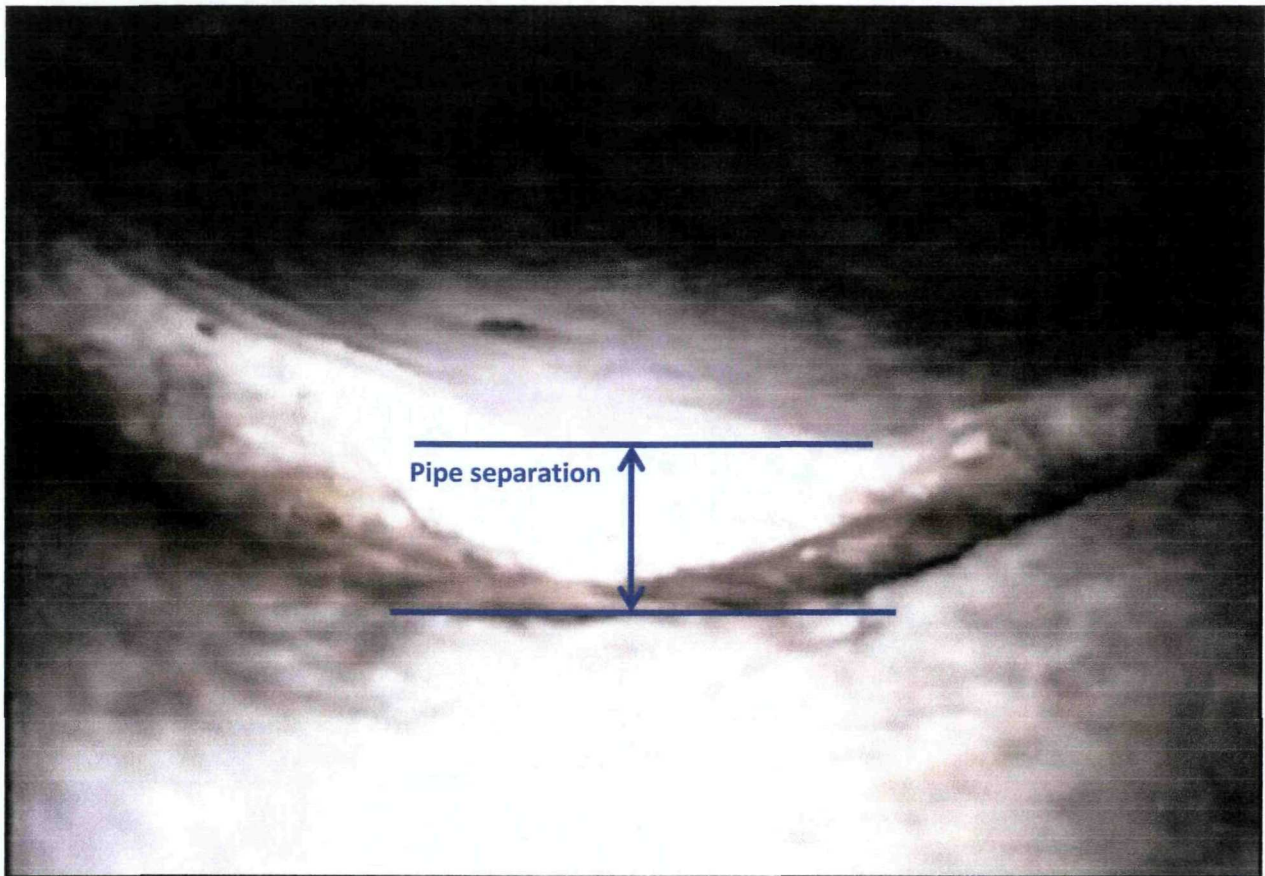
Figure 2: Drain 1 pipe joint gap

The inside of the CMP and the RCP are clean and there are no apparent large cracks in the pipe. There are perforations in the RCP that apparently allow water to flow into the pipe. It was noted that the drain is composed as individual 5 ft. segments. At each of the segments, there are separations in the pipe joints. It is noted that the separations are wider and are displaced more than any of the other joints in the other drain pipes as well as more than a typical RCP which have tight joints at the segments. It appears that water flows into the pipe at the pipe segments rather than at the perforations and that there has been embankment material that has been washed into the pipe through the joints. It appears that the individual segments of the pipe have been slightly rotated and displaced due to the missing material. A photograph copied from the video located at one of the larger pipe gaps is shown in Figure 2 below;

The camera inspection went a total of 90 ft. when it encountered a pipe joint that the camera could not pass but it was almost the total length of the video camera so the inspection was terminated. Other than the gaps at the pipe segments there were no other anomalies noted in drain1.

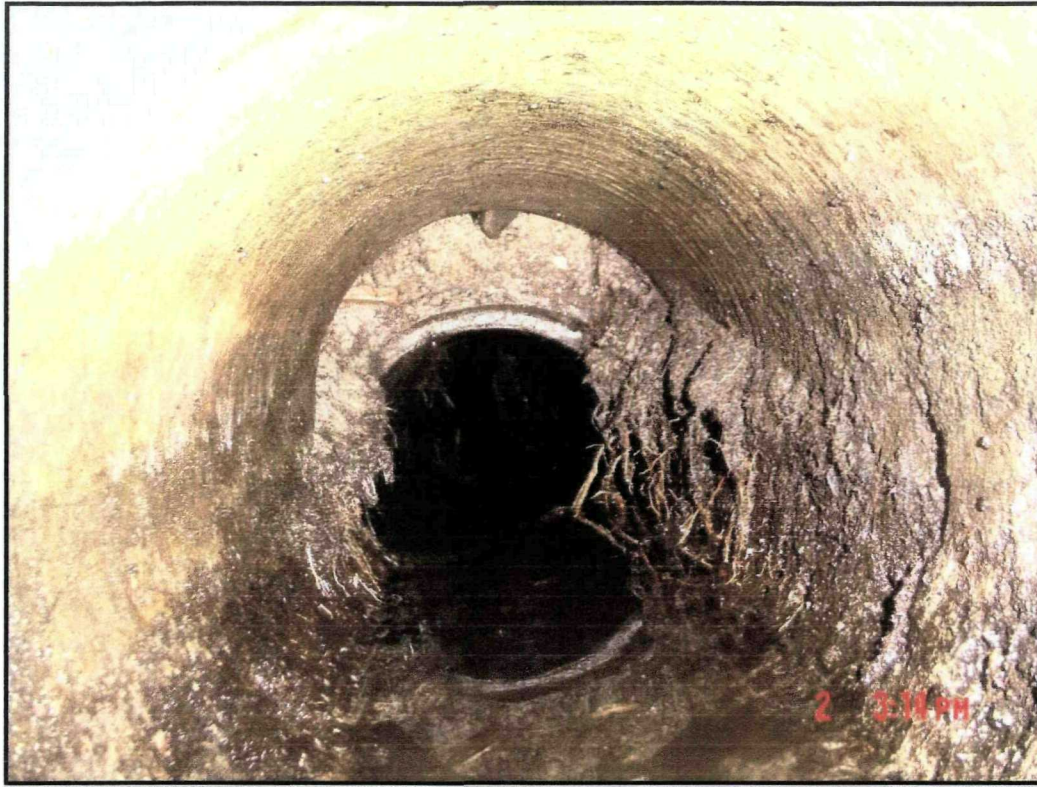
Figure 4: Drain 3 Concrete Headwall

Drain 3: Drain 3 is a 10-inch RCP in the left toe of the embankment. The first 5 ft. of drain 3 was unobstructed and then the camera encountered what appears to be a concrete headwall. The outlet end of Drain 3 abuts the headwall but has risen up above the invert of the pipe that is on the other side of the headwall. Once the camera crossed the headwall, it dropped onto the invert of the pipe and went immediately underwater. The water is very turbid and the light from the video camera could not illuminate the pipe so no video was available. A photograph of the headwall is shown in Figure 4 below;

The camera emerged from the water at approximately 31 ft. from the end of the outlet and then the path of the camera was relatively unobstructed. As can be seen in the video, the pipe appears open and there is water running in the invert of the pipe.

2. Drain 3 needs to be further inspected as it now appears that it is one of the drains that may give an indication of the internal parts of the embankment. It is recommended that the outlet end of drain 3 should be removed and allowed to drain out the water and dirt in the invert. Once the end is removed the pipe should be clear and can be re-inspected. It is unknown how far drain 3 goes into the embankment but a camera capable of at least 300 ft. should be available in the event that access can be obtained. Once the pipe is cleaned and inspected, the outlet end from the headwall down can be placed on a ¾-inch angular rock base and correctly aligned from the concrete headwall to prevent siltation at the outlet.

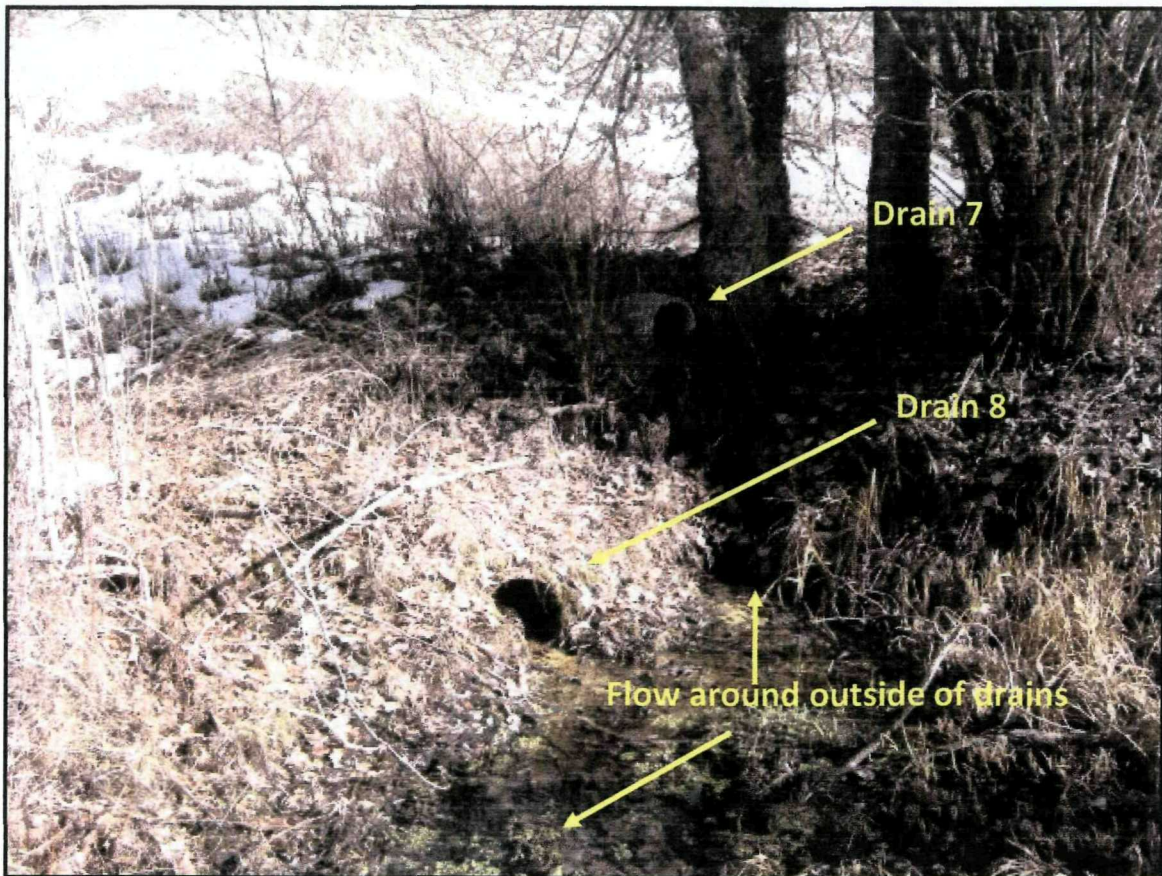
Figure 5: Flow from outside of drain 8

Drain 8: Drain 8 is an older corrugated metal pipe that appears to be in fair to poor condition. The first 5 ft. of the outlet end of the pipe has rusted and the metal is thin. After the outlet end, the metal appears to be in better condition. This drain has the lowest invert elevation of all the toe drains. The water that flows out of drain 8 is usually a low flow, but is clear and steady. There are some minor fluctuations in drain flow rate with seasonal inflows but the increase in flow mainly comes from the water flowing on the outside of the drain pipe rather than from the flow inside the pipe. The outlet of drain 8 sits in a very wet area where water flows out of the ground around the outside of the outlet of the pipe as well as out of the ground approximately 4 ft. to the left of the outlet of the drain, just below drain 7.

It is assumed that the water that would normally flow out of drain 7 is some of the water that appears below and next to drain 8 but that assumption is not certain. We have noted that the water that appears outside of the drain 7 and drain 8 fluctuates each year with the seasonal flow increases and decreases. A photograph of the water appearing on the outside of drain 8 is shown on Figure 5 below;

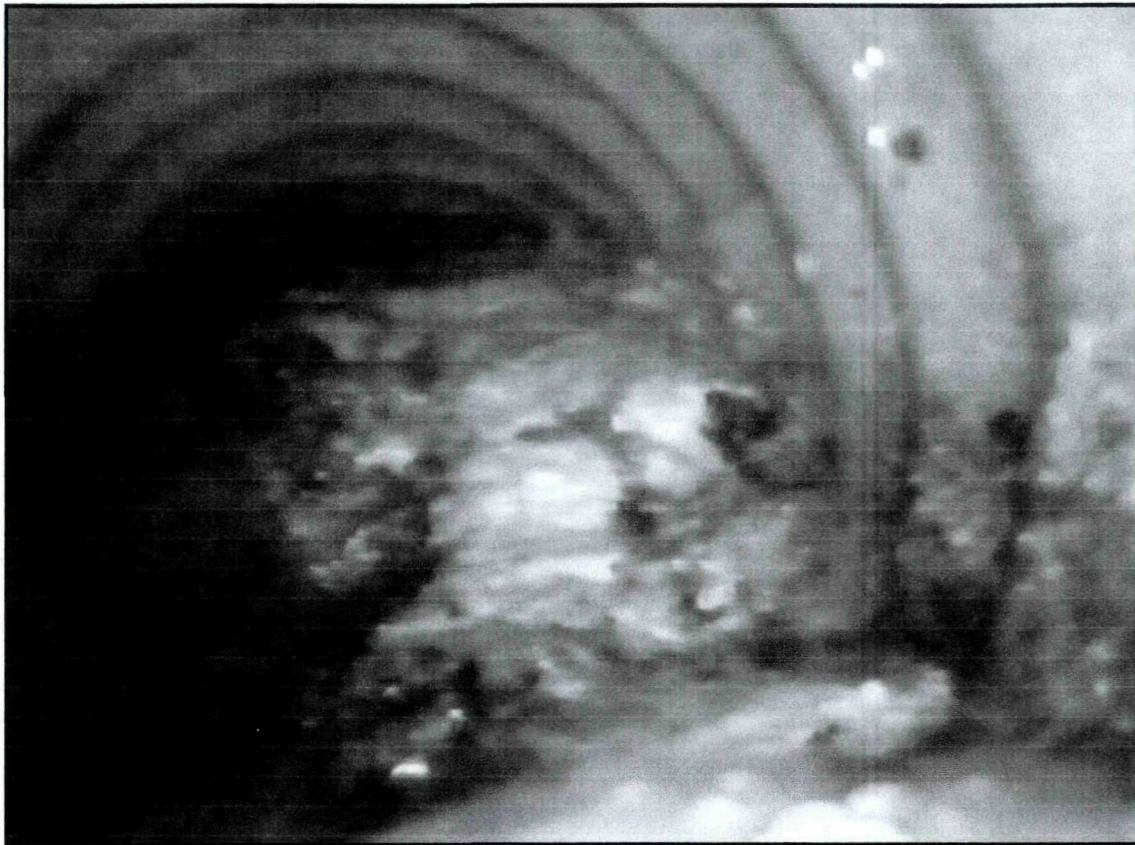
Figure 6: Drain 8 silt and clay in rock matrix at the terminal end

The video camera was able to travel 18.6 ft. into drain 8 before encountering a pile of rocks inside the pipe. There is the same tan silt or clay deposits on the invert of the pipe and inside the pile of rocks as was in drain 4 and drain 5. The rocks appear to be 1-1/2-inch angular rock with dirt, sand and roots inside the matrix of rocks. It does not appear that the pipe has collapsed in the area where the rocks are located but the rocks have migrated into the pipe from some upstream location. It appears that the smaller particles of rock and sand are migrating down the pipe. A copy of the video at the terminal end of the pipe is shown in Figure 6 below:

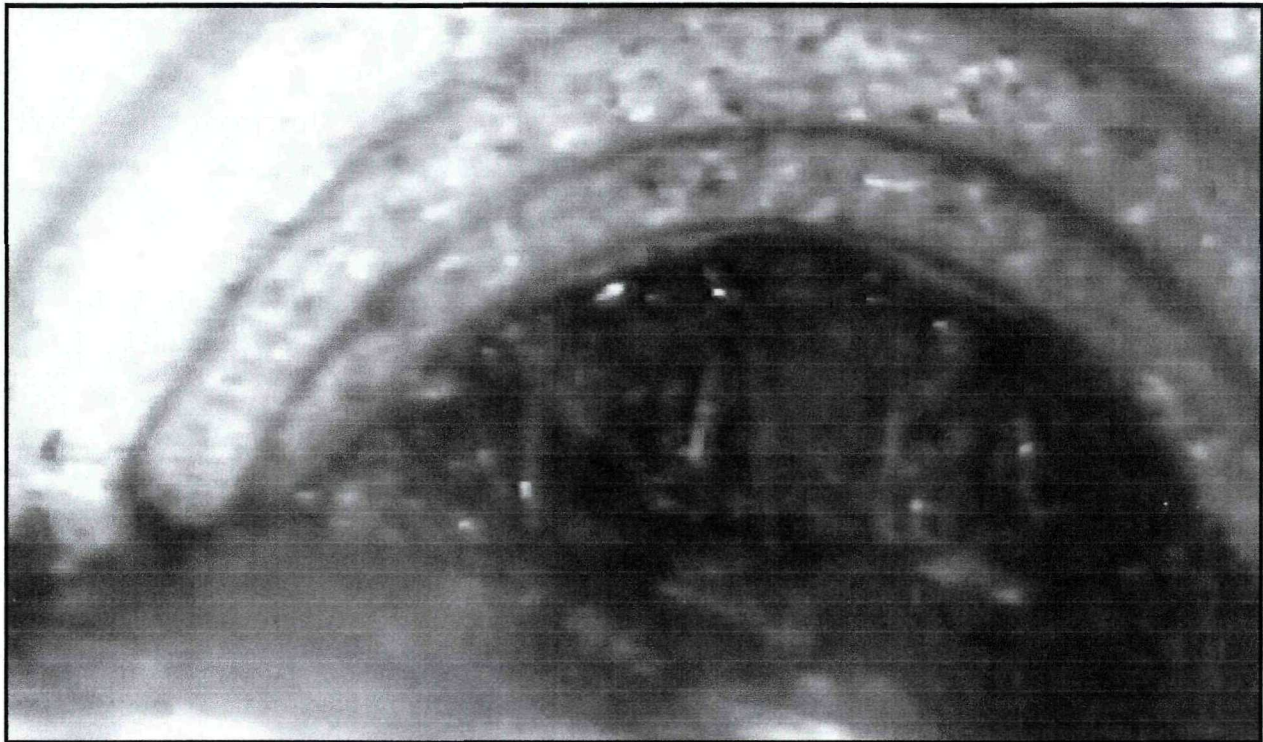
Figure 7: Terminal end of drain 10

Drain 10: Drain 10 and 11 are located approximately 4 ft. apart in the same location. Drain 10 is a 10-inch CMP and drain 11 is a 10-inch RCP. It is noted during the routine owner's inspections that the invert of the both of these pipes is continually covered in 1-inch to 3/4-inch rocks and that the rocks appear below the pipe outlet on the streambed. In drain 10 the camera was pushed in 13.6 ft. where the camera encountered what appeared to be a concrete headwall or the terminal end of a concrete pipe. The end of the pipe was packed tight with rocks and dirt as well as roots and no voids were readily apparent. The rocks appeared to be 3/4-inch to 2-inch angular and round rock. The water was emerging from the rocks from the top and bottom and flowing into the pipe. Water also appeared to flow out of

the pile of rocks that had migrated into the pipe on the invert indicating that water is flowing into the invert under pressure from the perforations. A copy of the video at the terminal end of drain 5 is shown in Figure 7 below:

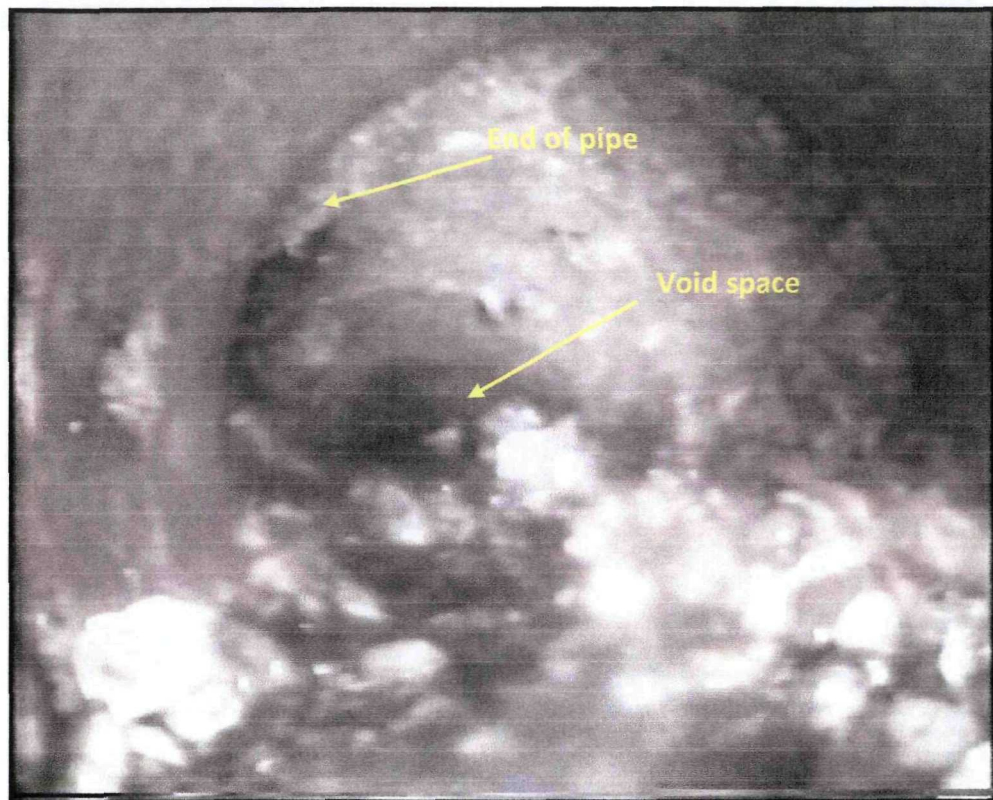
Figure 8: Terminal end of drain 11

Drain 11: Drain 11 is a RCP in fair to good condition near the outlet. There are 1-inch to $\frac{3}{4}$ -inch rocks on the invert, the same as the condition in drain 10. The camera sled was able to travel 10 ft. into the pipe when it encountered the first rocks that had migrated into the invert of the pipe. It was also noted that water is spraying into the pipe from the perforations along the invert. This would seem to indicate that there is water present in the embankment that is under pressure up to at least the elevation of the invert of the pipe. The camera was pushed over the rocks on the invert to a total length of 12.6 ft. and then was stopped at a larger pile of rocks at the terminal end. The terminal end of at least one of the pipe segments could be seen and then there was a void space past the end of the pipe with a pile of round rocks past the void space. The round rocks were $\frac{3}{4}$ -inch to 1-inch round rocks, with sand. The rocks and sand have migrated into the pipe and have left the void space. There was also water emerging from the bottom of the rocks and flowing into the pipe. A copy of the video at the terminal end of the pipe and the void space at the end of the pipe is shown in Figure 8 and Figure 9 below;

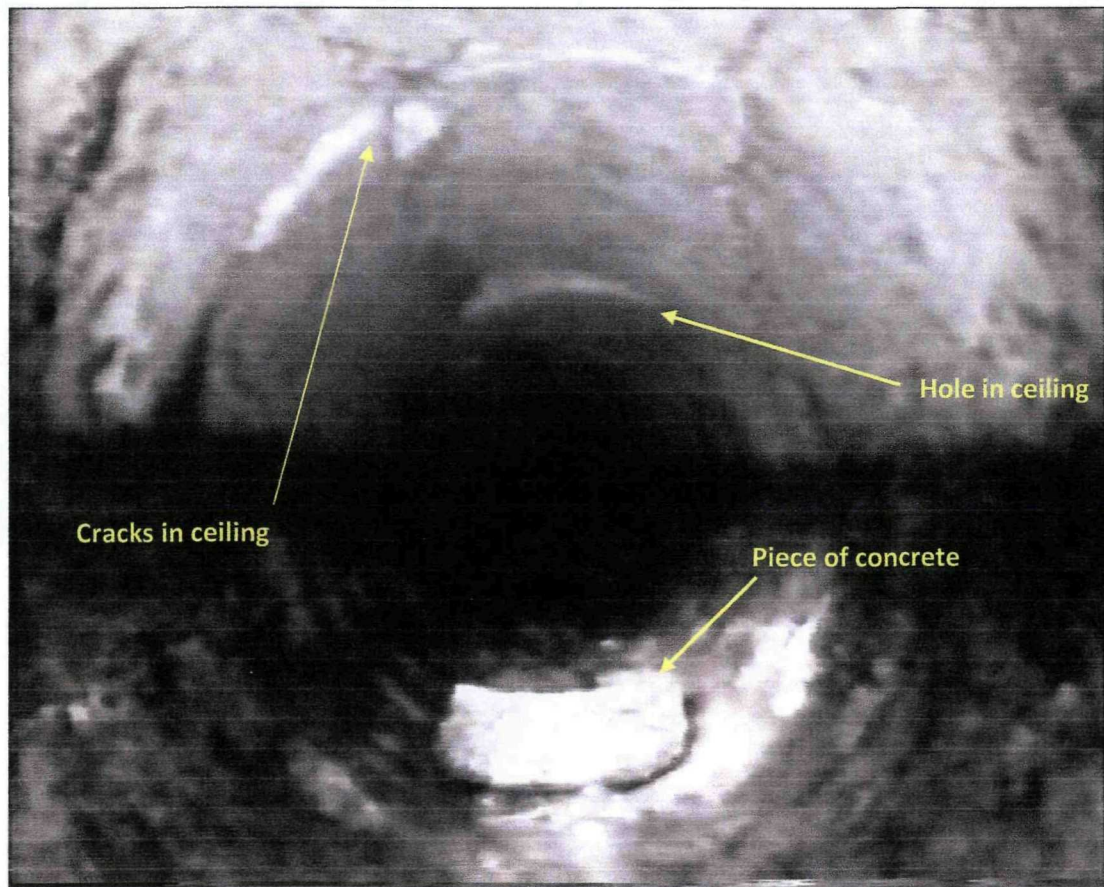
Figure 10: Drain 12 at location of concrete piece and ceiling cracks

Drain 12: Drain 12 is 8-inch RCP and is the smallest of the toe drains. Drain 12 has a clear and steady drain flow that changes with the seasonal fluctuations of the inflow. The lower end of the drain was fairly clear although there is a small deposit of sand and gravel in the invert of the pipe approximately 20 ft. into the pipe. It was noted that the video camera recorded flow into the drains from the perforations on the lower sides of the pipe until approximately 41 ft. into the drain where the flow ceased. The camera was able to be pushed another 10 ft. into the pipe where it encountered a pile of wet sands and gravel on the invert of the pipe and finally a complete blockage of the pipe. The material at the terminal end is round rock and is approximately 1-1/2-inch diameter with coarse sand. The material was wet but there did not appear to be water flowing out of the material. It is also noted that the pipe appears to have been crushed at approximately 30 ft. in from the end of the pipe and the pipe appears out of round for much of the length beyond 30 ft. There are also cracks in the pipe and a piece of the concrete from the ceiling that has fallen onto the invert of the pipe at 45 ft. in from the end. A copy of the video from drain 12 where the concrete piece from the ceiling is located is shown in Figure 10 below;

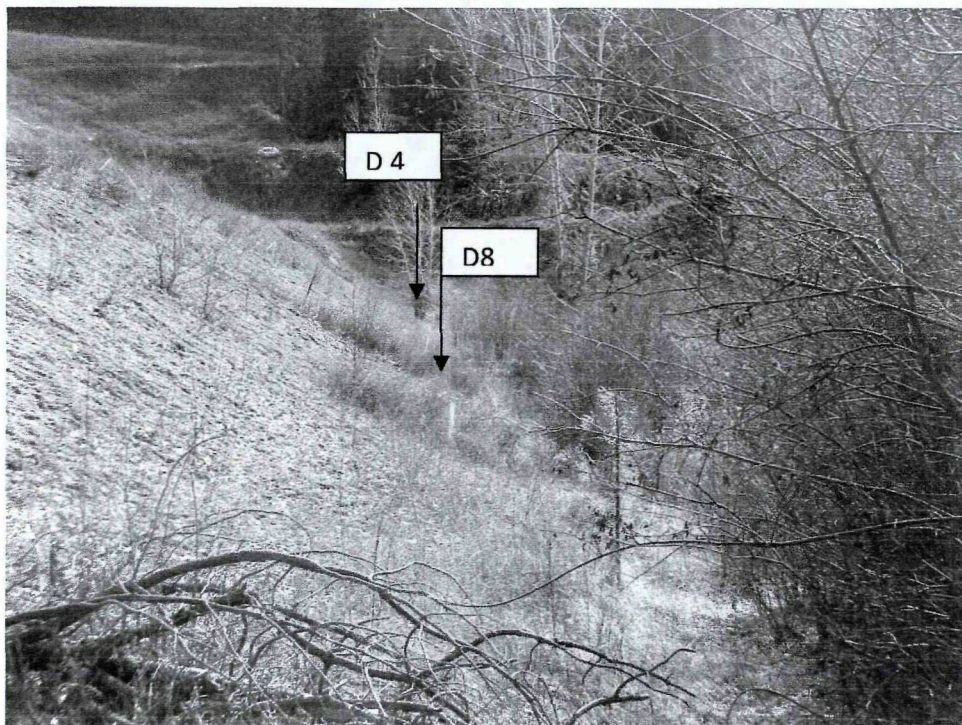
Figure 11: Terminal ends of drain 4 and drain 8 on the toe of the embankment.

The Wednesday March 3rd survey was conducted to determine if there is some correlation to the terminal end of the drains. It was found that the ends of drains 12, drain 9, and drain 5 are in somewhat of an alignment and that drains 4, 8, 10, and 11, are in another alignment. Shown below in Figure 11 is the lath at the terminal end of drains 4 and 8 and in Figure 12 is the terminal end of drains 5, 9 and 12, as well as drains 10 and 11.

As can be seen the terminal ends do appear to be in somewhat of an alignment. Drains 4, 8, 10, and 11 are at a location that averages 14 ft. from the toe of the embankment and drains 5, 9, and 12 are at an average distance of 45 ft. from the toe of the embankment. Drains 4, 8, 10, and 11 are basically at the toe of the embankment and drains 5, 9, and 12 are just below the downstream crest of first lift on the embankment. The drains 5, 9, and 12 are not at an equal distance below the crest of the first lift. Drain 12 is just below the crest, drain 5 is approximately 10 ft. below the crest and drain 9 is in the middle between the two.

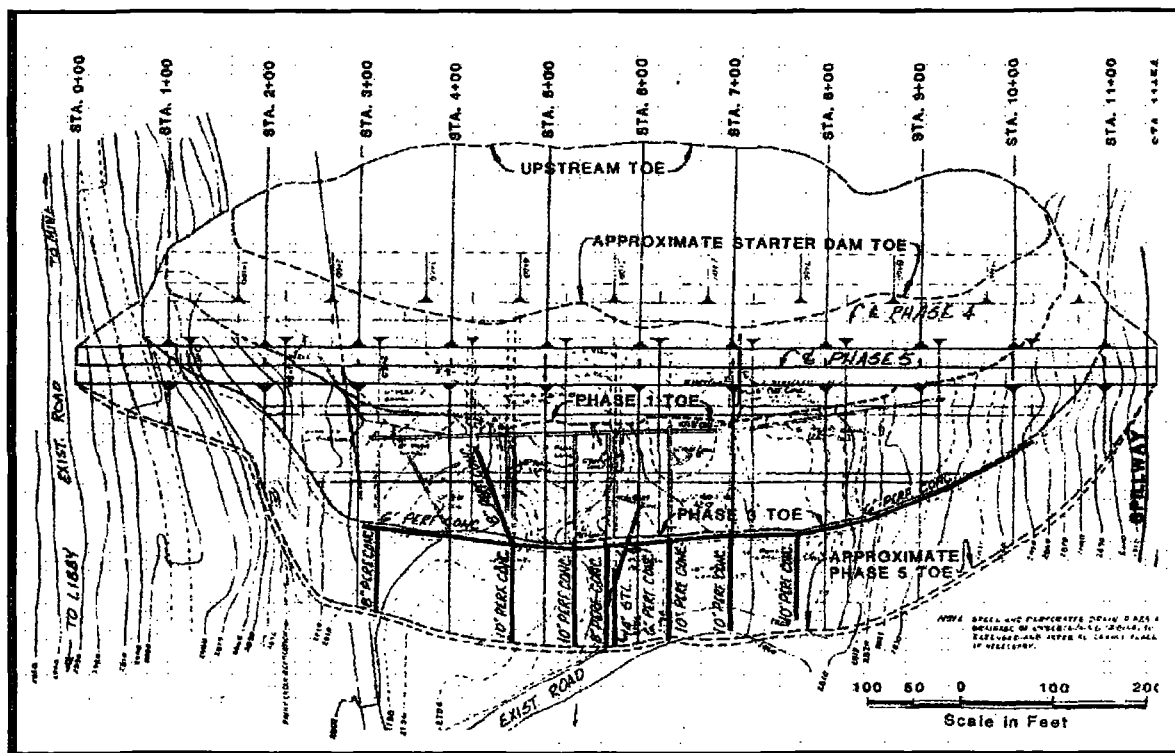
Figure 13: Phase 1 Dam Safety Inspection Assumed Location Toe Drains

The Harding Lawson statement is supported by the plan drawings that were provided as part of the US COE Phase 1 Dam Safety Inspection conducted by Morrison-Maierle for the COE in 1982. There are two drawings available from the 1982 Morrison-Maierle Phase 1 Dam Safety Inspection Report; a plan view and a cross section. Copies of the Phase I inspection drawings are provided in Appendix C, page C1 and C2. A copy of the plan view shown on page C1 in the appendix showing the assumed location of the drains is shown in Figure 13 below:

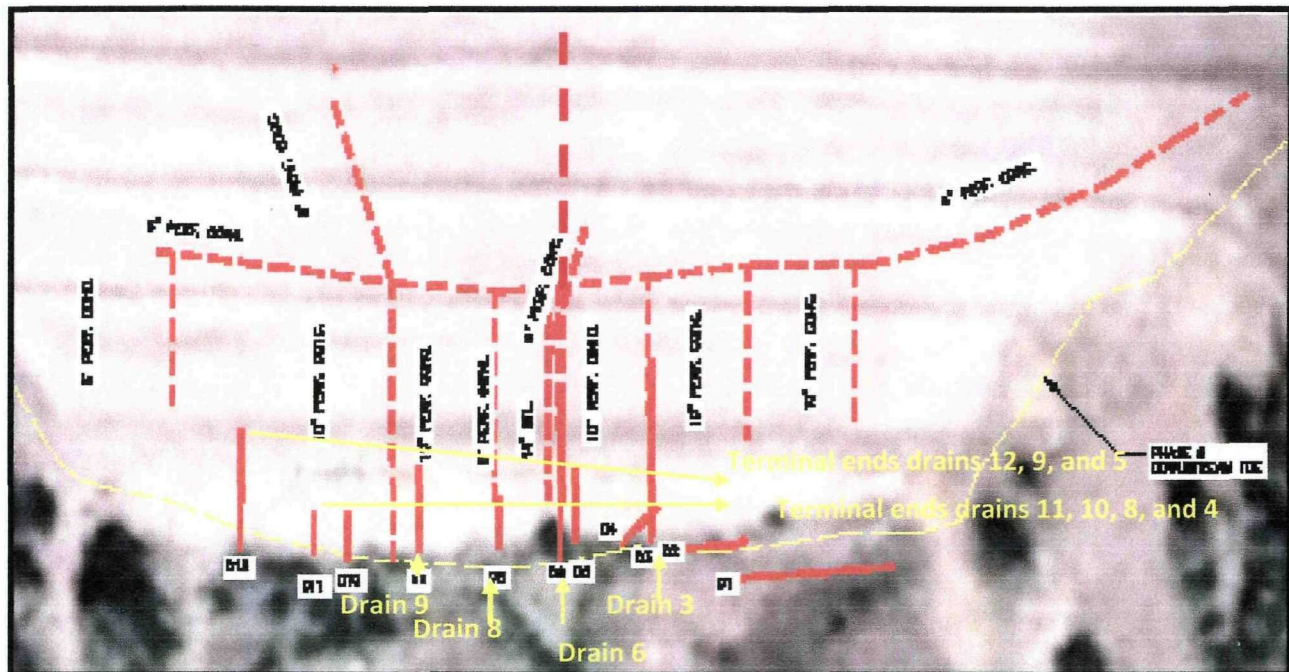
Figure 14: Assumed and Existing Toe Drains

The dashed lines in Figure 14 and on the drawing in the appendix are the 1982 assumed locations and the solid lines are the 2010 existing locations. As can be seen, the assumed and existing locations for drain 3 and drain 6 do appear to align with the 14-inch steel drains and the 10-inch perforated concrete shown on the assumed location drawing. There may also be some correlation to the locations of drain 8 and drain 9 but even these assumptions would not describe why there were eight (8) drains assumed and there are twelve (12) drains existing. A description of the length of each of the existing drain pipes and the height of the overburden from the field notes and field survey is provided in Appendix D to this report.

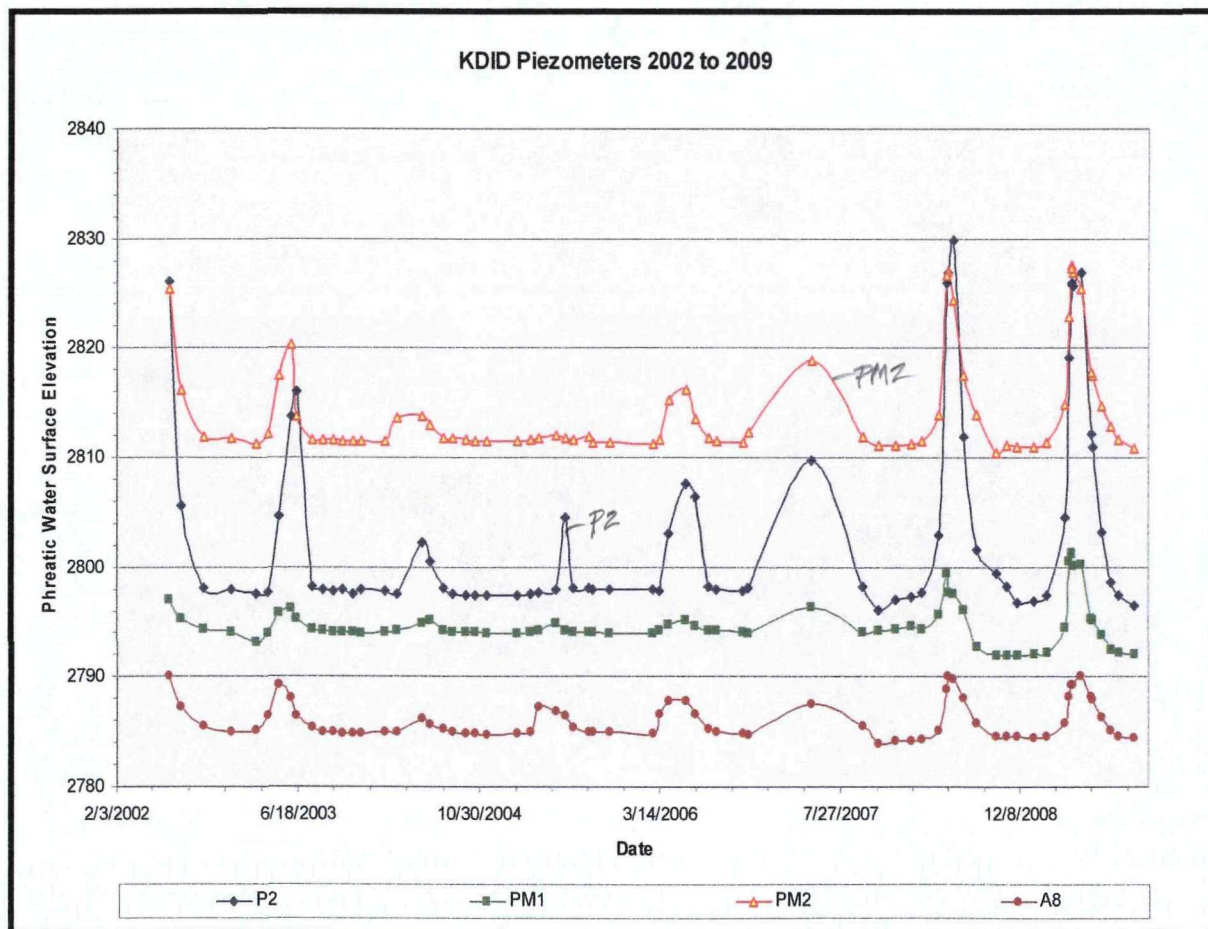
Figure 15: Phreatic Water surface 2002 to 2009

In the Harding Lawson report, Stability of Slopes, page 15 of 22, they state that "...we believe that the groundwater level immediately upstream of the embankment does not rise above the foundation level." In the BHI report on the Piezometer and Toe Drain Discharge Monitoring of February 2010 it is noted that the phreatic water surface in piezometer P2 on the upstream face of the embankment rises as much as 30 ft. to 40 ft. above the foundation level. It is also known that the phreatic water surface drops each year to the bottom of the piezometers after the high spring flows pass. A graph of the phreatic water surface in the four piezometers that have an active rising water surface since 2002 is shown in Figure 15 below;

Continuous records for the piezometers have only been available since 2002 which indicates that either the piezometers have always risen and it was just not known by Harding Lawson Associates, or the rise in phreatic water surface has occurred some time after the 1992 Haring Lawson report. As was stated in the Piezometer and Toe Drain Discharge Monitoring report, the rise in phreatic water surface is still 70 ft. below the maximum phreatic surface assumed in the stability analysis so the rise in phreatic water

surface was not tied to a stability issue. But, if there has been a radical change in the phreatic water surface since 1992, it may have been caused by the collapse of the drains.

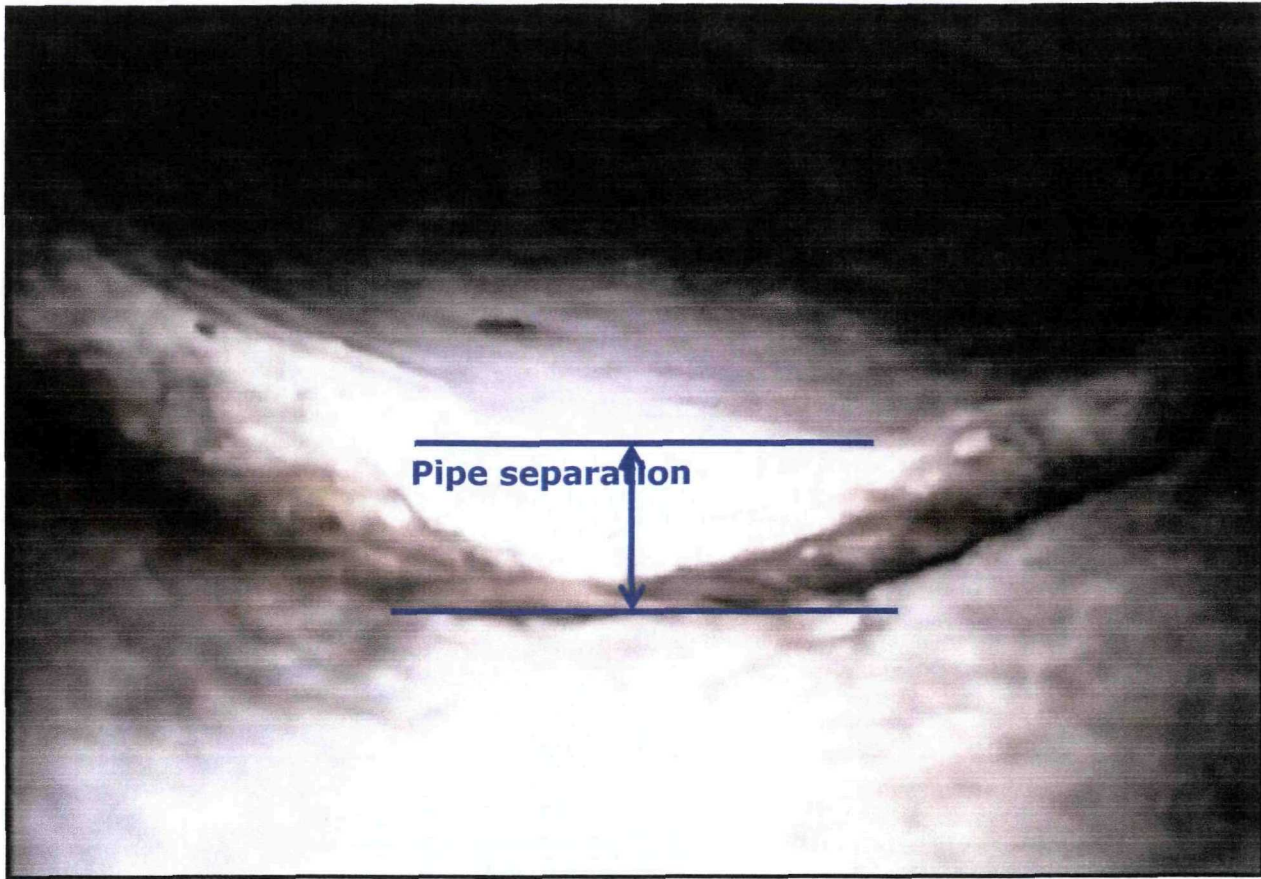
Drain 1: Pipe Joint Separation

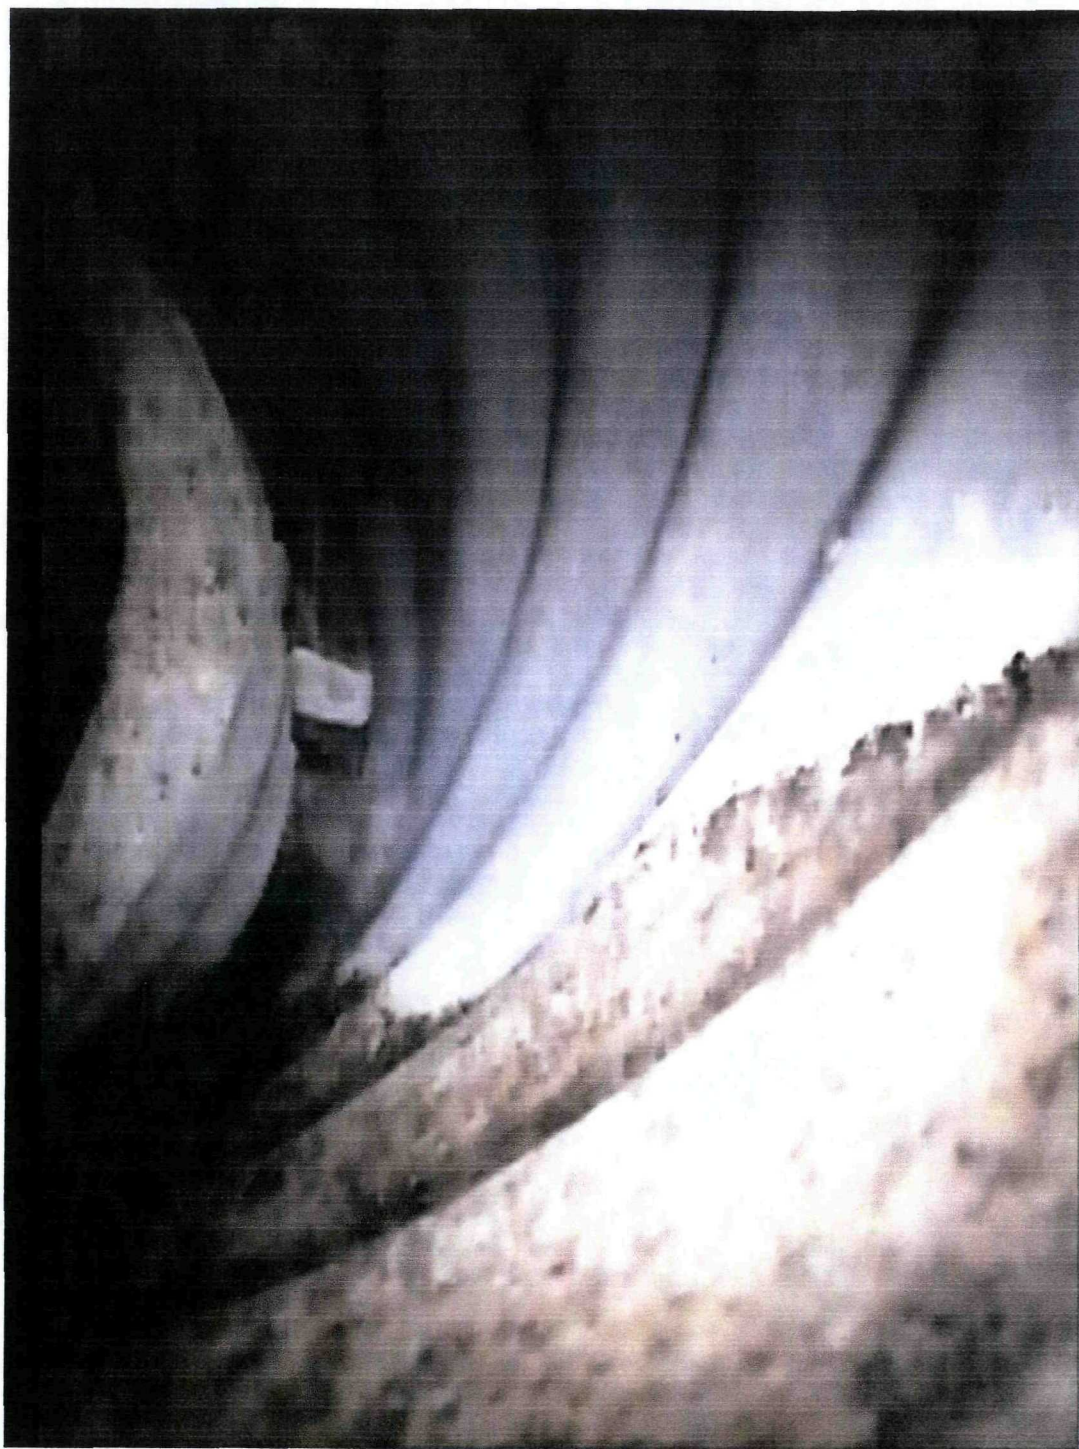
Drain 1: CMP to RCP at transition at top of pipe

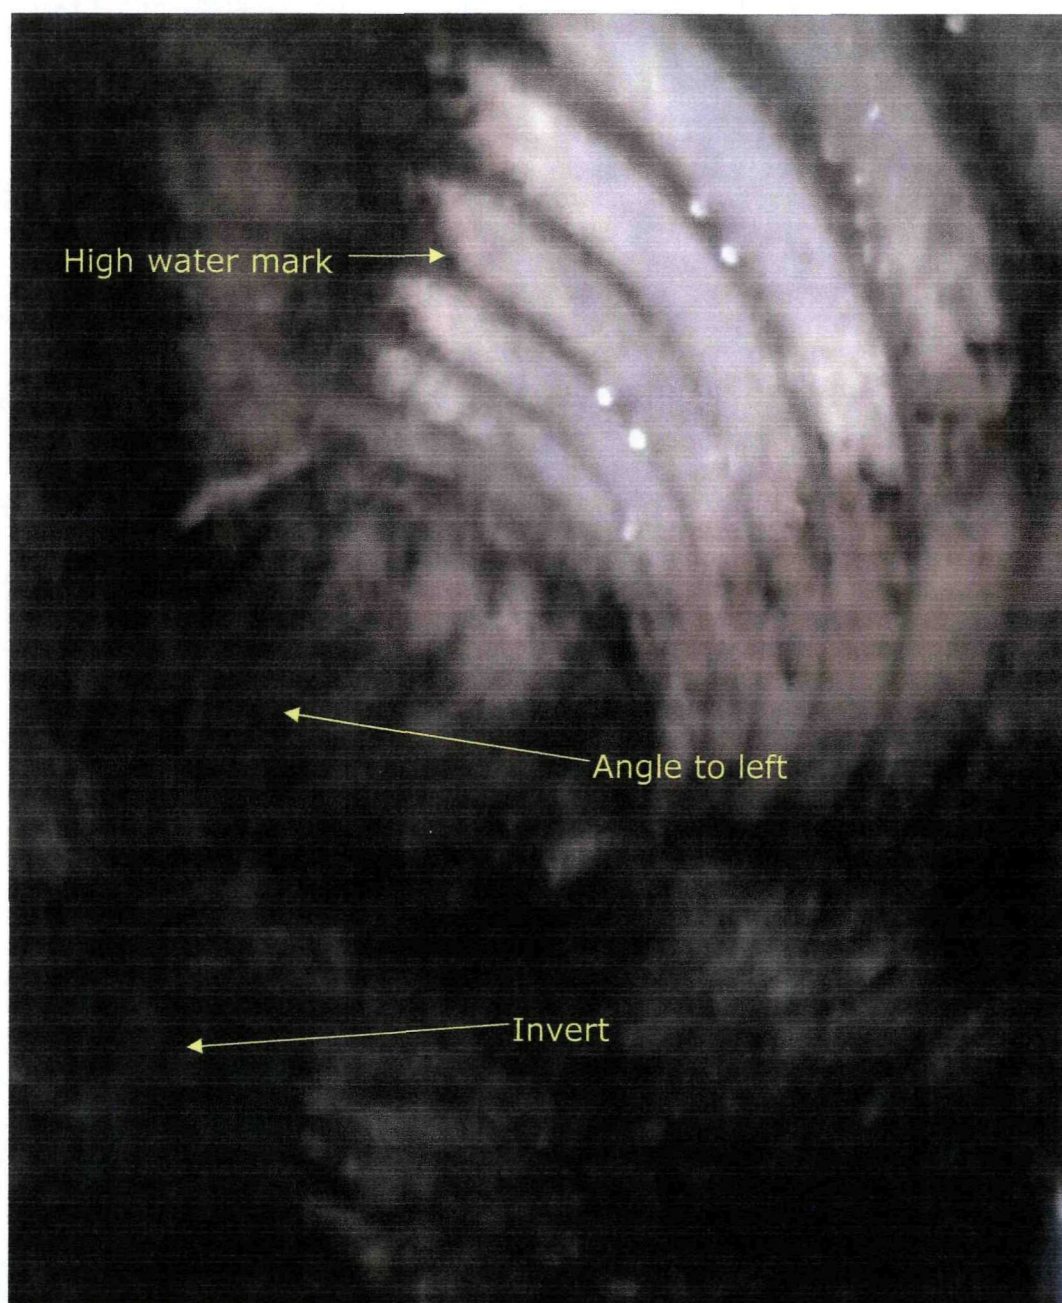
Drain 2: Angle to the left and high water mark

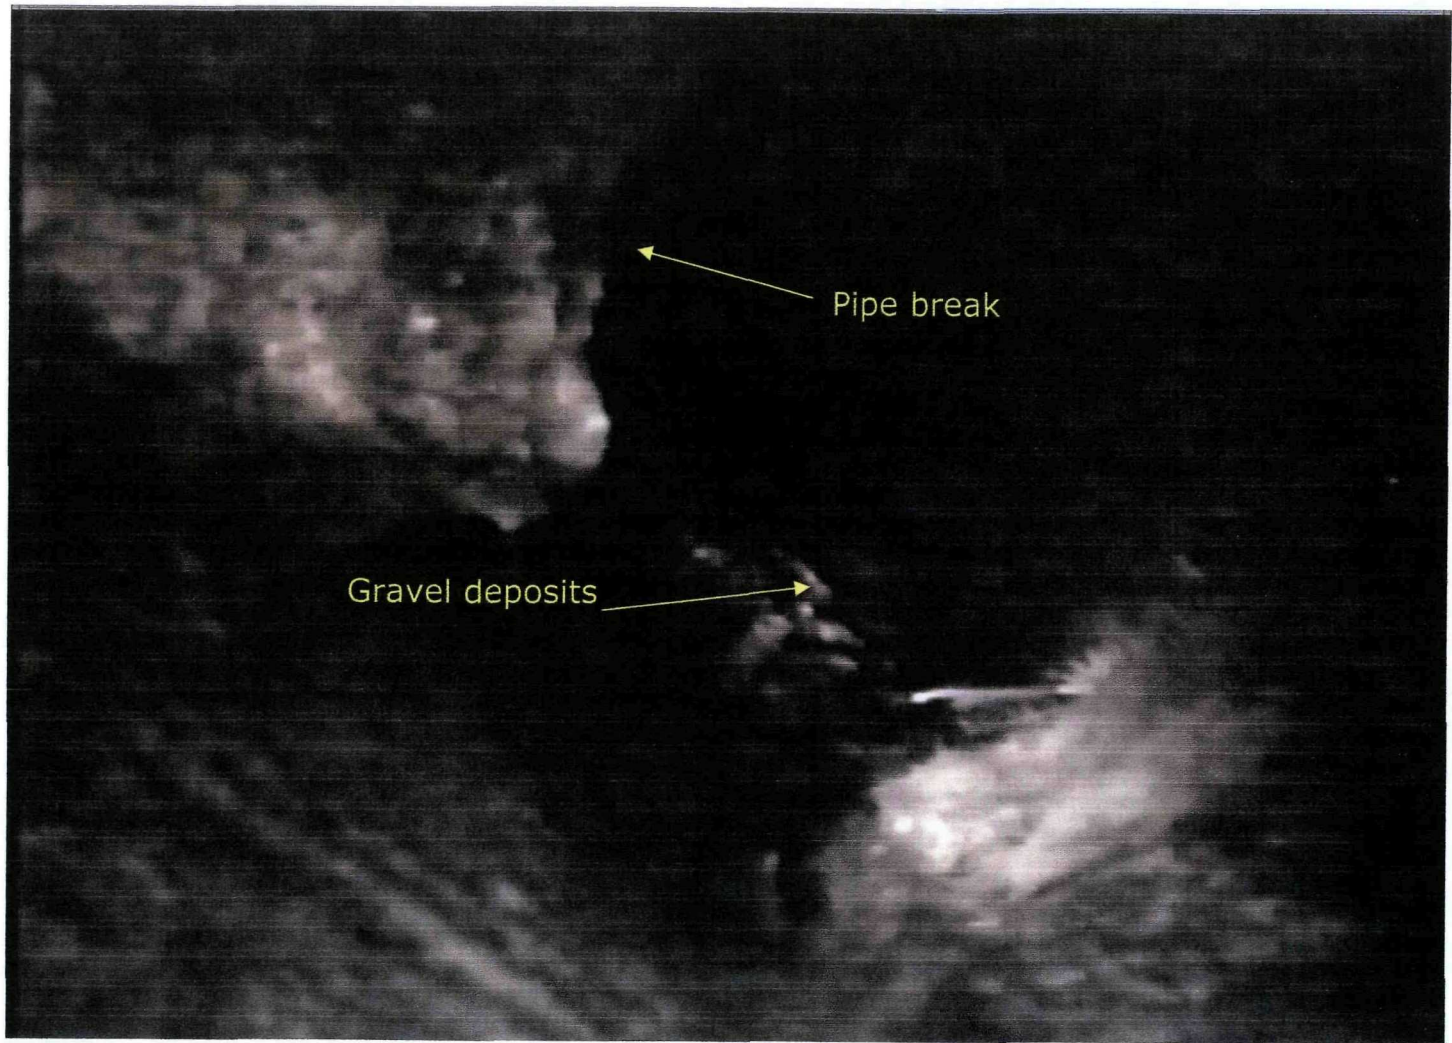
Drain 2: Break in pipe and gravel deposits

1. The break in drain 2 needs to be repaired. As the break is near the surface and easy to access, the pipe can be excavated, and a new segment added to the end of the drain.

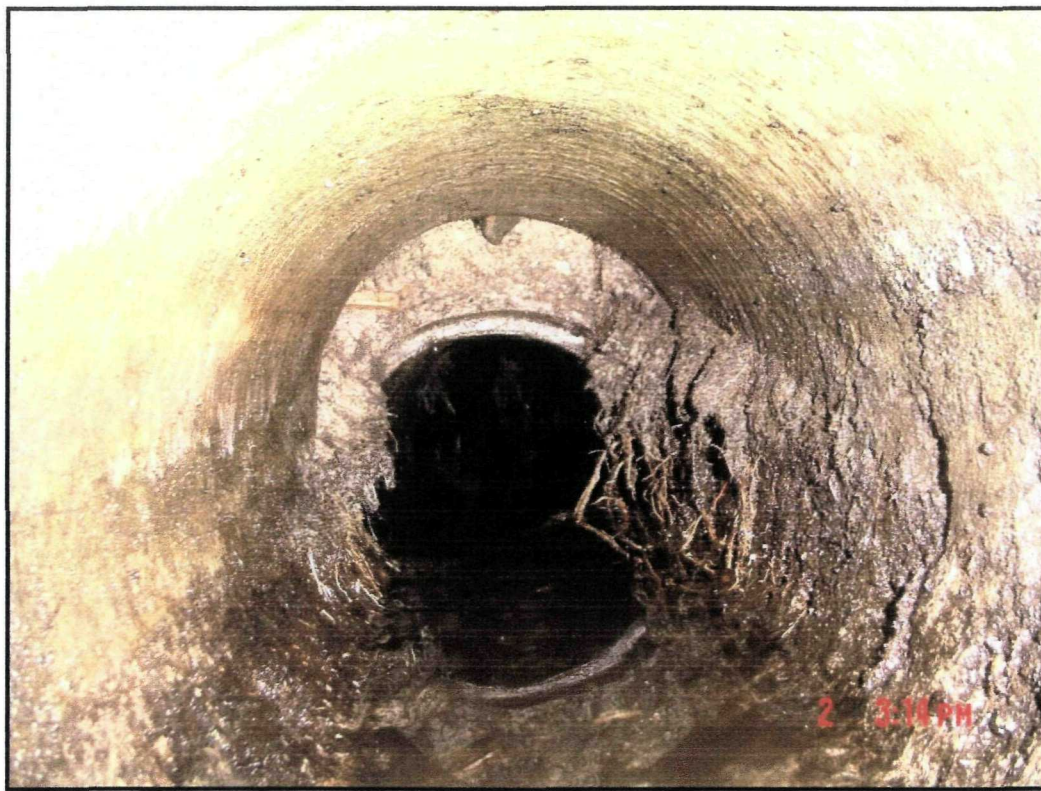
Drain 3: Concrete headwall

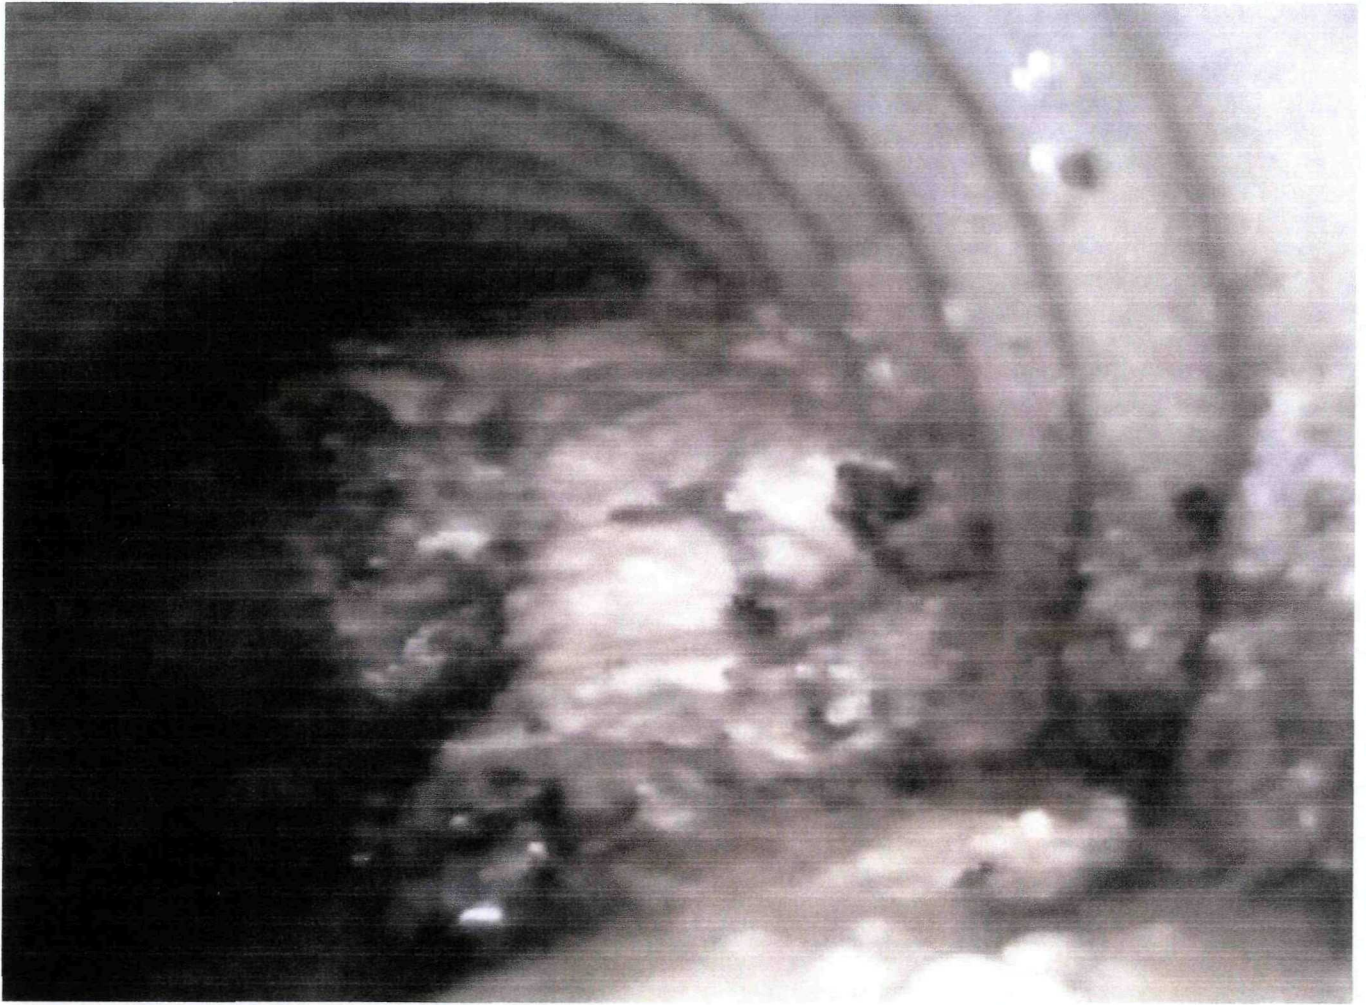
Drain 8: Silt or Clay deposit on rock deposits at the end of Drain 8
